AMERICAN RAILCAR LEASING, LLC
TANK CAR QUALIFICATION FORM

Reporting Mark and Car Number: 5HPX-205631
DOT Specification: DOT 111A100W-5
Facility: Fritcer
Address: 1965 South Blvd Brewton AL 36426

TANK CAR QUALIFICATION REPORT

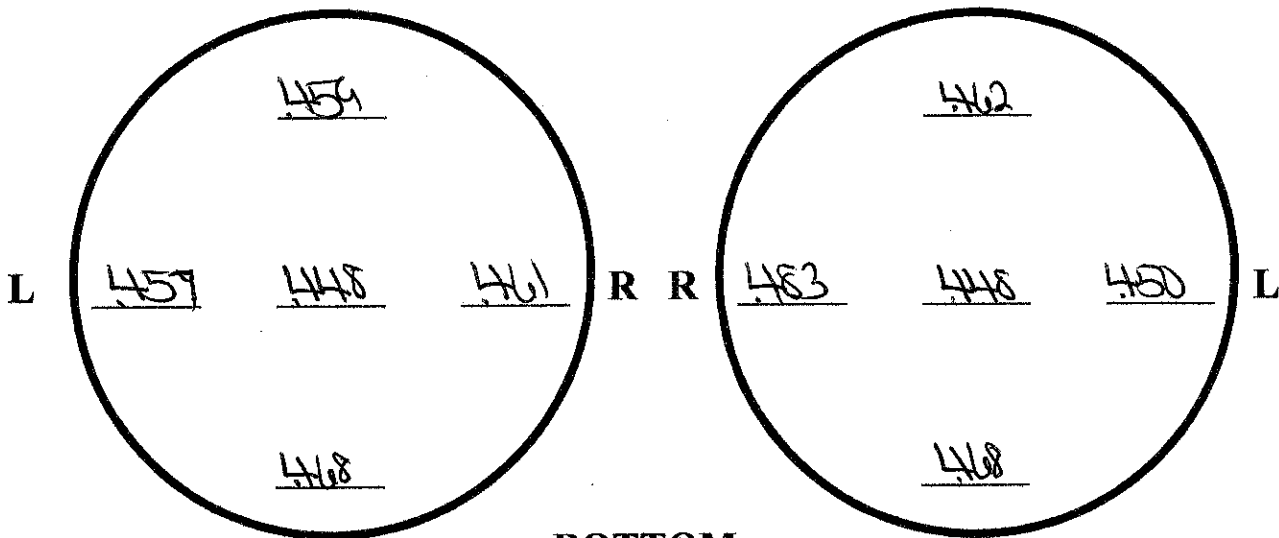
NOZZLE AND SUMP THICKNESS READINGS		
	A-END	B-END
MANWAY NOZZLE	.650	.656
OD NOZZLE		
SAFETY VALVE NOZZLE	.302	.294
TOP UNLOADING NOZZLE	.627	.627
SUMP		
OTHER		
OTHER		
OTHER

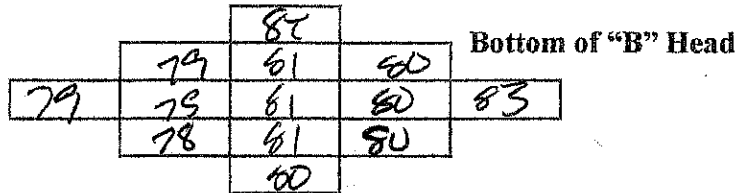
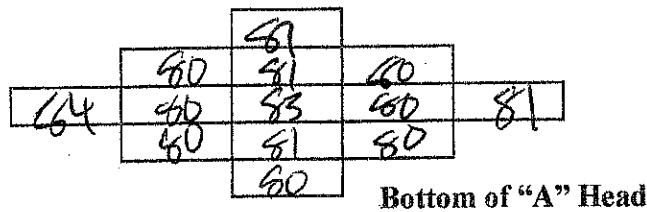
B-Head Seam	5:00	3:00	2:00	1:00	12:00	11:00	10:00	9:00	7:00
Seam 1	79	80	80	79	84	83	79	79	78
	80	81	80	80	80	83	81	77	78
	80	80	80	81	81	81	81	86	77
Seam 2	91	80	80	80	87	81	83	86	78
	81	79	80	81	80	80	81	79	77
	81	79	83	81	81	82	81	79	77
Seam 3	79	78	80	84	88	81	83	79	78
	79	77	80	83	86	83	81	79	78
	79	79	83	83	84	83	84	79	78
Seam 4	80	77	79	80	87	80	85	81	78
	81	78	79	80	79	80	85	83	79
	82	79	80	82	82	79	81	79	80
Seam 5	82	80	81	78	80	79	83	79	78
	83	81	80	80	80	83	87	81	78
	81	81	81	81	80	83	81	83	78
Seam 6	80	80	82	83	83	87	81	79	78
	80	79	81	83	80	81	81	79	81
	80	78	81	79	84	81	80	78	80
Seam 7	81	82	83	81	80	83	80	77	80
	83	81	81	81	83	84	80	79	79
	79	81	83	82	80	83	79	78	78
Seam 8									
Seam 9									
A-Head Seam									
	5:00	3:00	2:00	1:00	12:00	11:00	10:00	9:00	7:00
